Timber in Contact with Soil

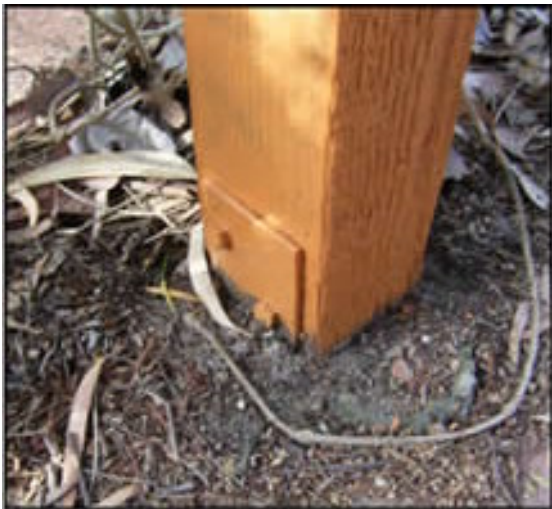
◀ Here the pergola post has a stirrup, however the soil has been allowed to build up around the base. This results in termites gaining access to the house as they are able to "bridge" any termite barriers that are in place.

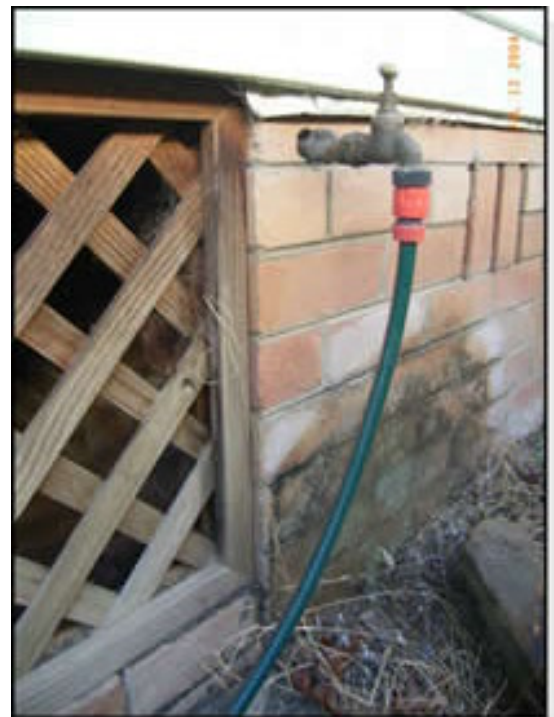
Here is an area of concern, as lattice is in contact with the soil, plus there is a leaky tap which has been a problem for some time, evident by the stain on the brickwork. The dampness would attract termites and could gain access to the house via the lattice which is bypassing the ant caps.

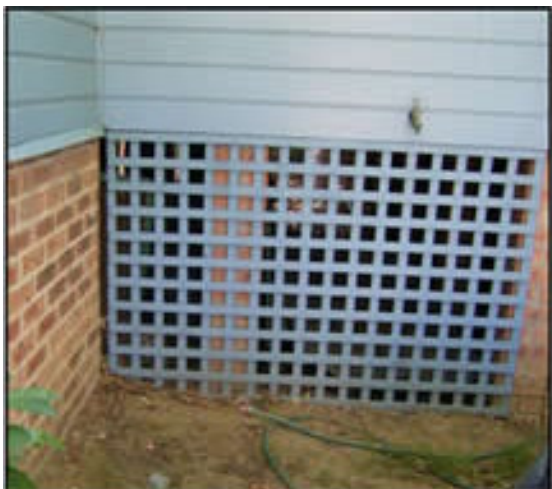
◀ Lattice is used in many homes to block access to subfloors. Care should be taken that it does not come in contact with the soil if it is attached to the house.
